Housing Subsector Report Mercy Corps Intervention Areas 2015 Gorkha Earthquake, Nepal

September 2015

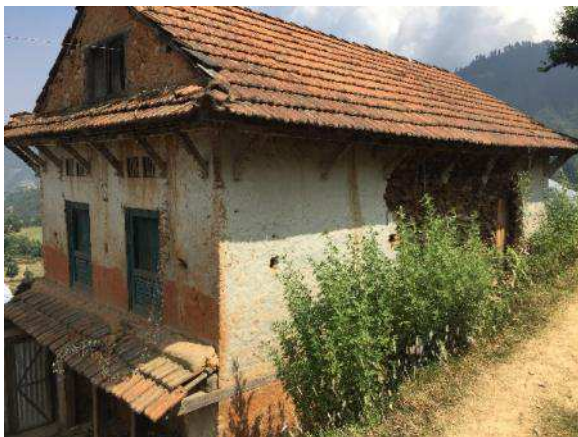
Figure 3.17. Cheta Nath's house at Dhungakharka VDC

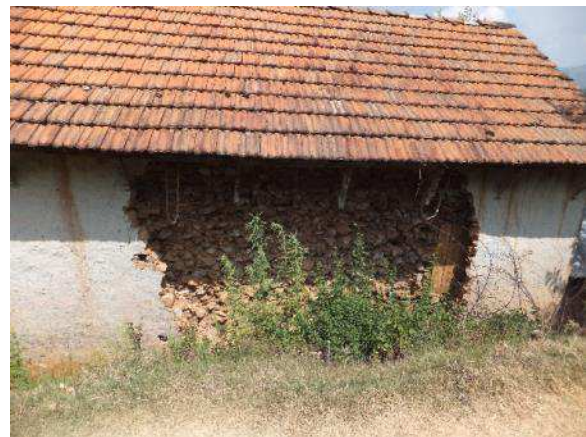
Dhungkharka had a moderate level of damage. Except for 2 or 3 structures that had completely collapsed, most of the structures were standing and had suffered mostly out of plane failures and corner cracks.

Figure 3.18. Out of plane wall failure of Cheta Nath's house

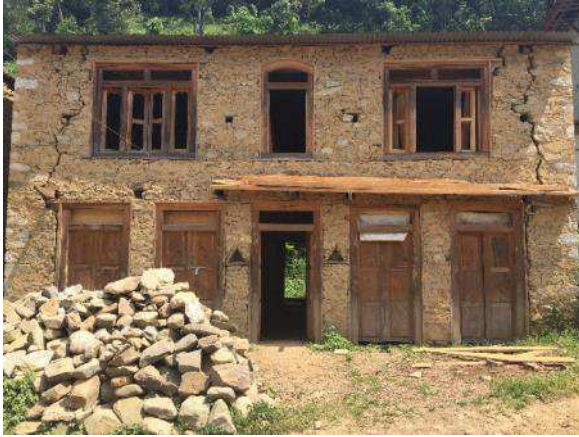
Figure 3.19. Corner cracks of Sita Ram House (builder).

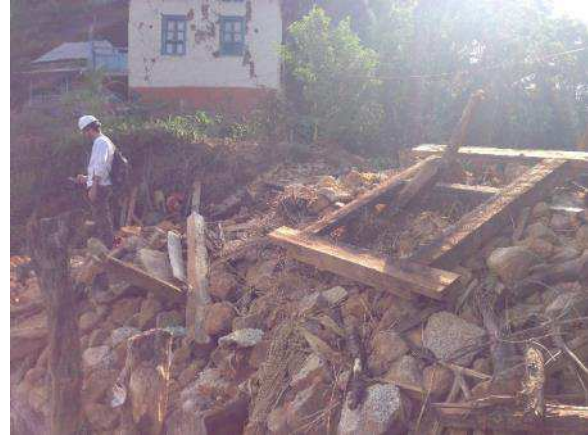
Figure 3.20. Complete collapse of Keshab Prasad's house

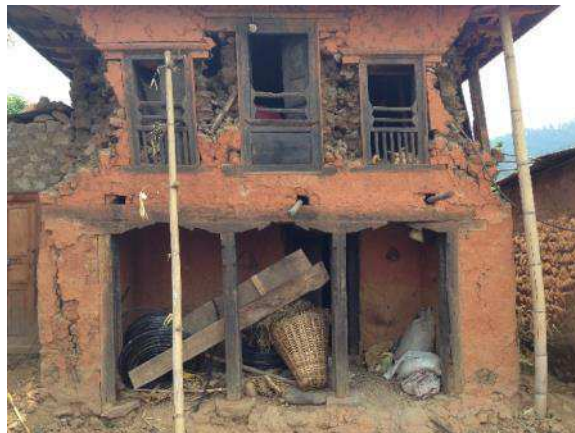
Figure 3.21. Damaged two story house in Mahankal Chaur

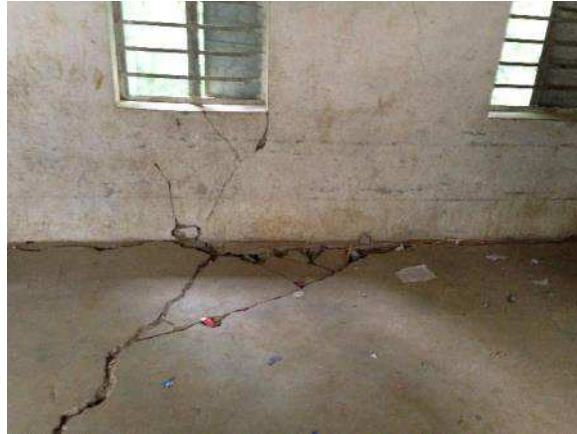
In Chyasingkharka the damage was moderate. There was one school building that was red tagged because of numerous cracks in the ground floor slab and in some of the walls. There were also a few houses that had cracks in the walls.

Figure 3.22. School building with cracks in Chyasingkharka.

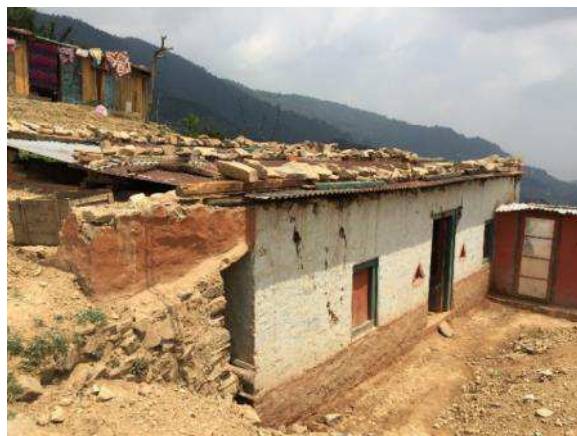
The damage in Chalal Ganeshthan was moderate to severe and varied by ward (local district). In Ward 9, which is on top of a mountain ridge, the damage was extensive. However, in Ward 2, which is down in a valley, the amount of damage was relatively less. There were many structures in Ward 9 that had wall cracks and out of plane wall failures. Some of the homeowners in Ward 9 have already started to demolish their partially damaged house to first floor level. Most of the households are planning to put CGI roofing on top of the ground floor after demolishing the other floors in order to continue to live in the house.

Figure 3.23. One of the houses in Chalal Ganeshthan Ward 9 where the upper floors were demolished and the ground floor level covered with CGI sheets.

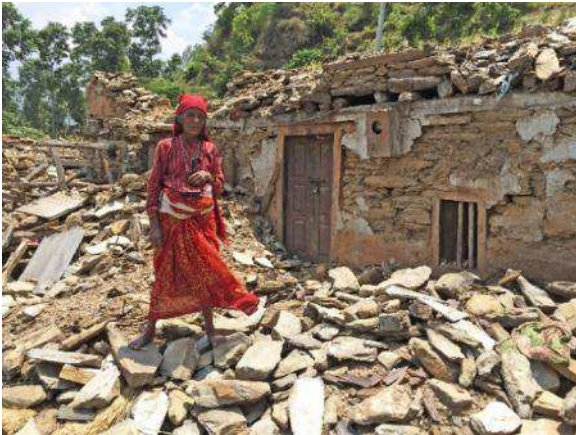
The damage in Ramche was severe. Approximately 90% of the houses observed had completely collapsed and the remaining structures were partially collapsed or damaged to the extent that they were not safe for future habitation. Many people have built temporary

Figure 3.24. Devi Timilsina in front of her collapsed house

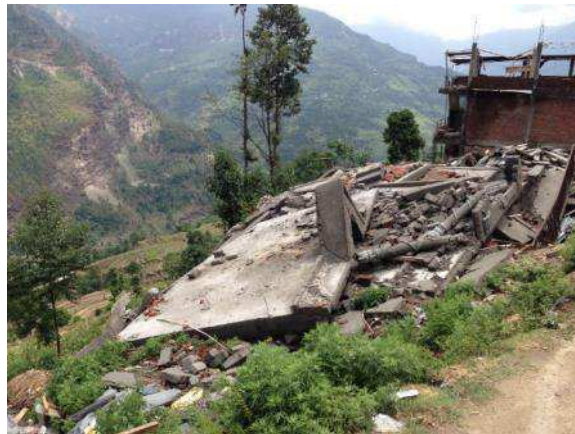
The damage in Maneshwor was moderate to severe and appeared to be dependent on their location. Houses that were built close to the edge of the hillside suffered more damage than those that were built further back. Most of the hillside houses had completely collapsed. Houses built with concrete frames and brick infill construction were among those that were highly damaged or had collapsed. The survey team was told that the structures in Maneshwor were built without consulting or drawing approval by the VDC as it is not a requirement.

Figure 3.26. Collapsed concrete frame brick infill house in Maneshwor

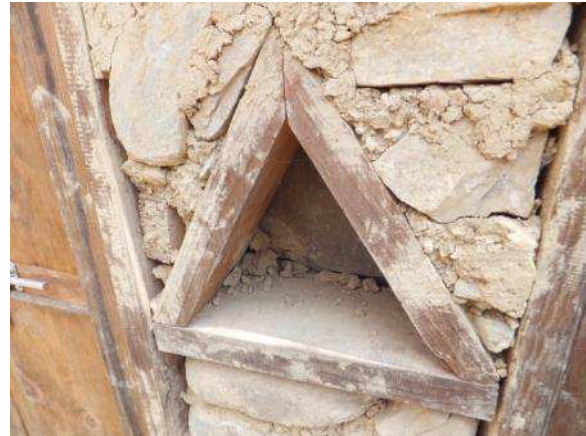
In Dhungharka and Chalal Ganeshtan it was common practice to install triangular holes in the walls at the front of the house. These holes were for religious shrines. While the survey team did not see any evidence of earthquake damage to the walls resulting from the presence of these holes, their presence within the shear walls of the houses would likely have an effect on the capacity of the walls to resist seismic loads. These holes were not seen in the other villages.

Figure 3.30. Wall opening for shrine, Dhungharkha

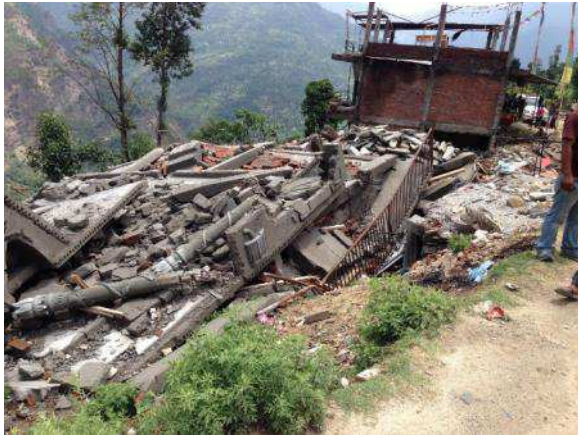
Figure 4.1. Collapsed framed infill house, Maneshwor

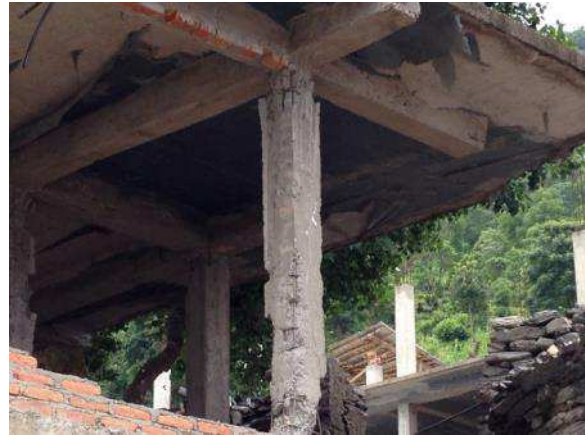
Figure 4.2. Damaged framed infill house, Maneshwor
