BUILD CHANGE NEEDS ASSESSMENT AND POST-DISASTER RECONNAISSANCE REPORT

2023 TÜRKİYE EARTHQUAKE

MARCH 2023

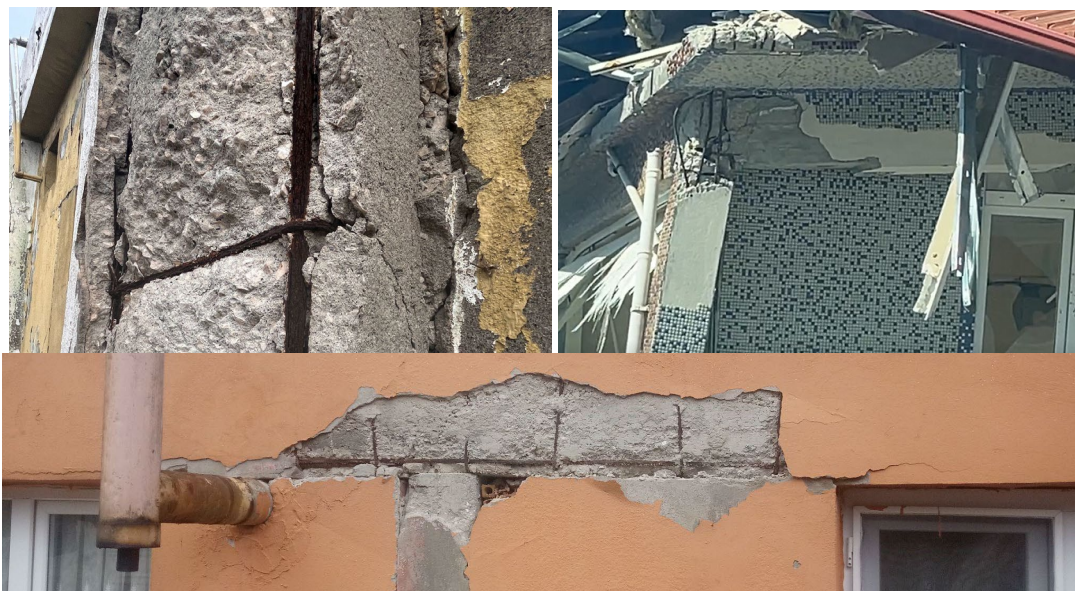
- Weak and/or soft story: Mixed use buildings (residential and commercial) often have open and/or taller ground floors with fewer columns or walls, creating a weak and/or soft story with significantly less stiffness compared to the rest of the floors. Soft-story collapses occurred in heavily damaged areas (Figure 22).

FIGURE 21 *Poor concrete quality and reinforcement detailing*

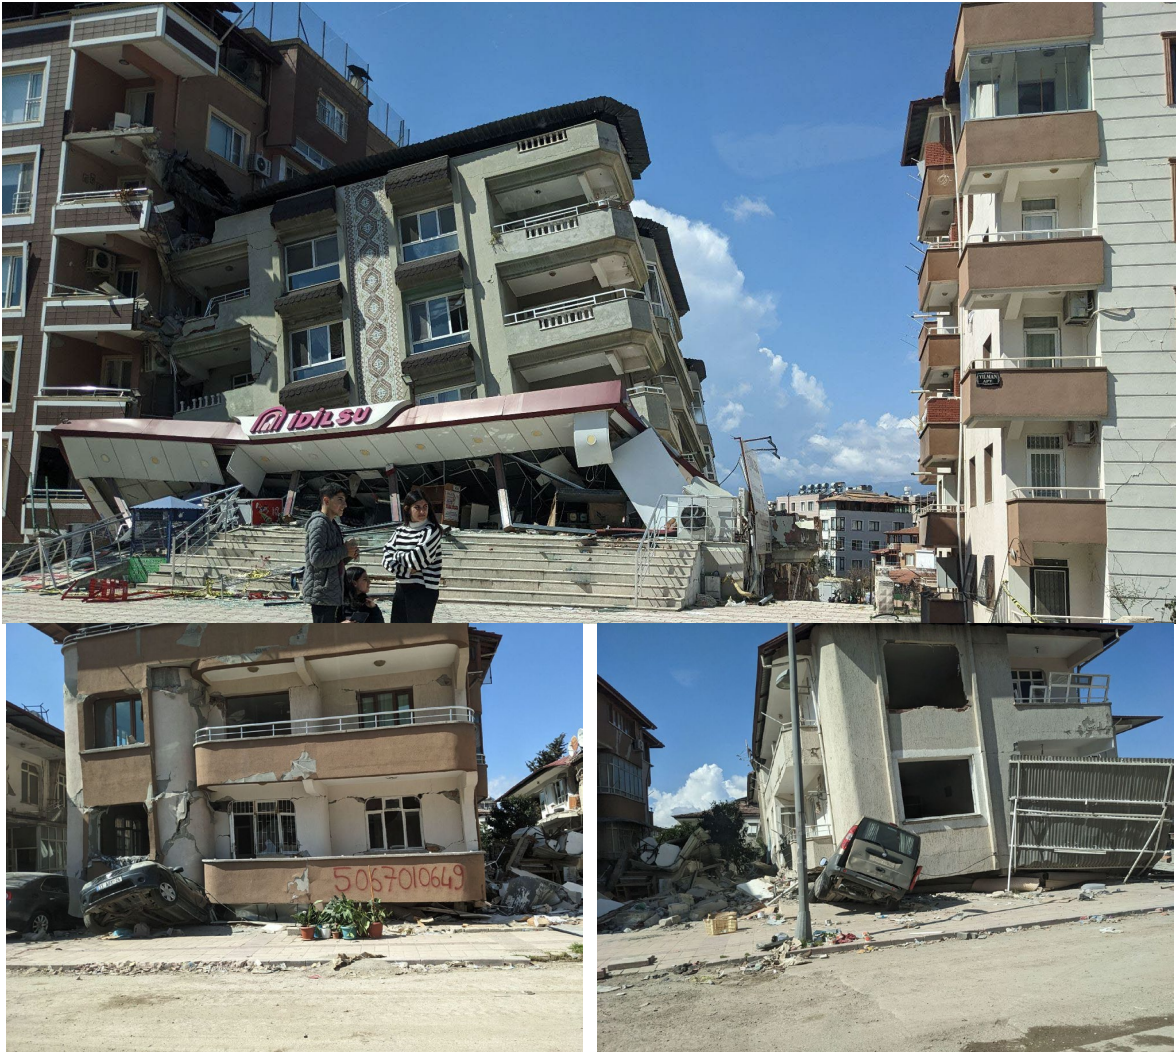
FIGURE 22 *Pounding and soft stories*

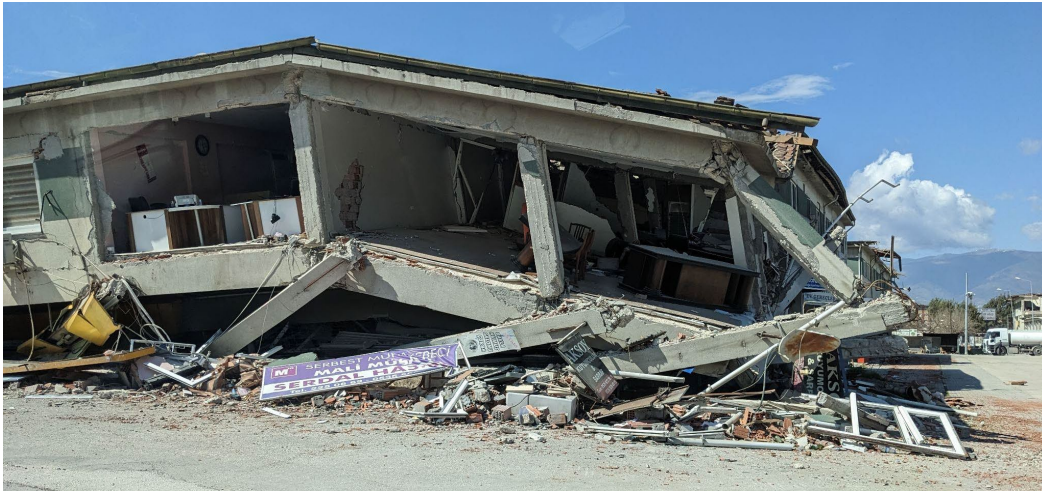
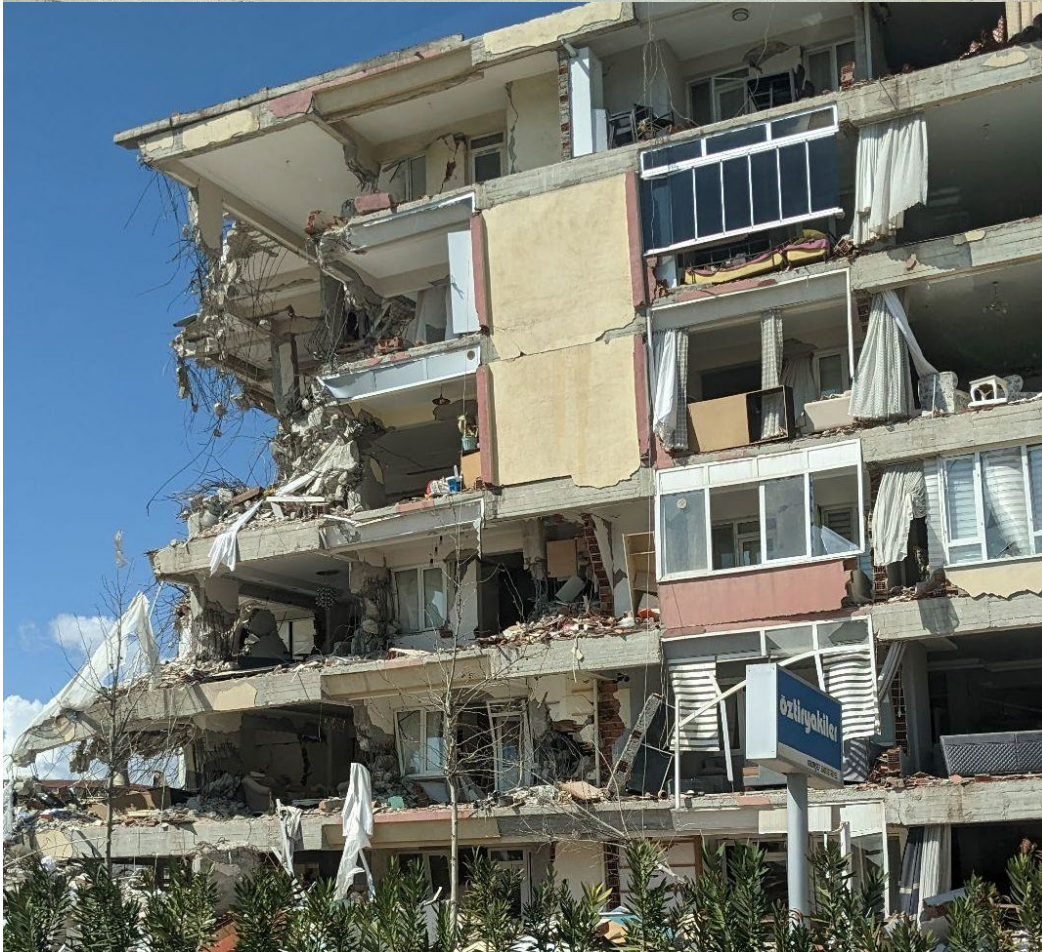
unreinforced masonry infill walls and parapets was commonly observed. Excessive stirrup spacings in frame elements was also noted as a reason for damage.

FIGURE 23 *Damage assessment of non-ductile RC Frames with or without infill walls.*

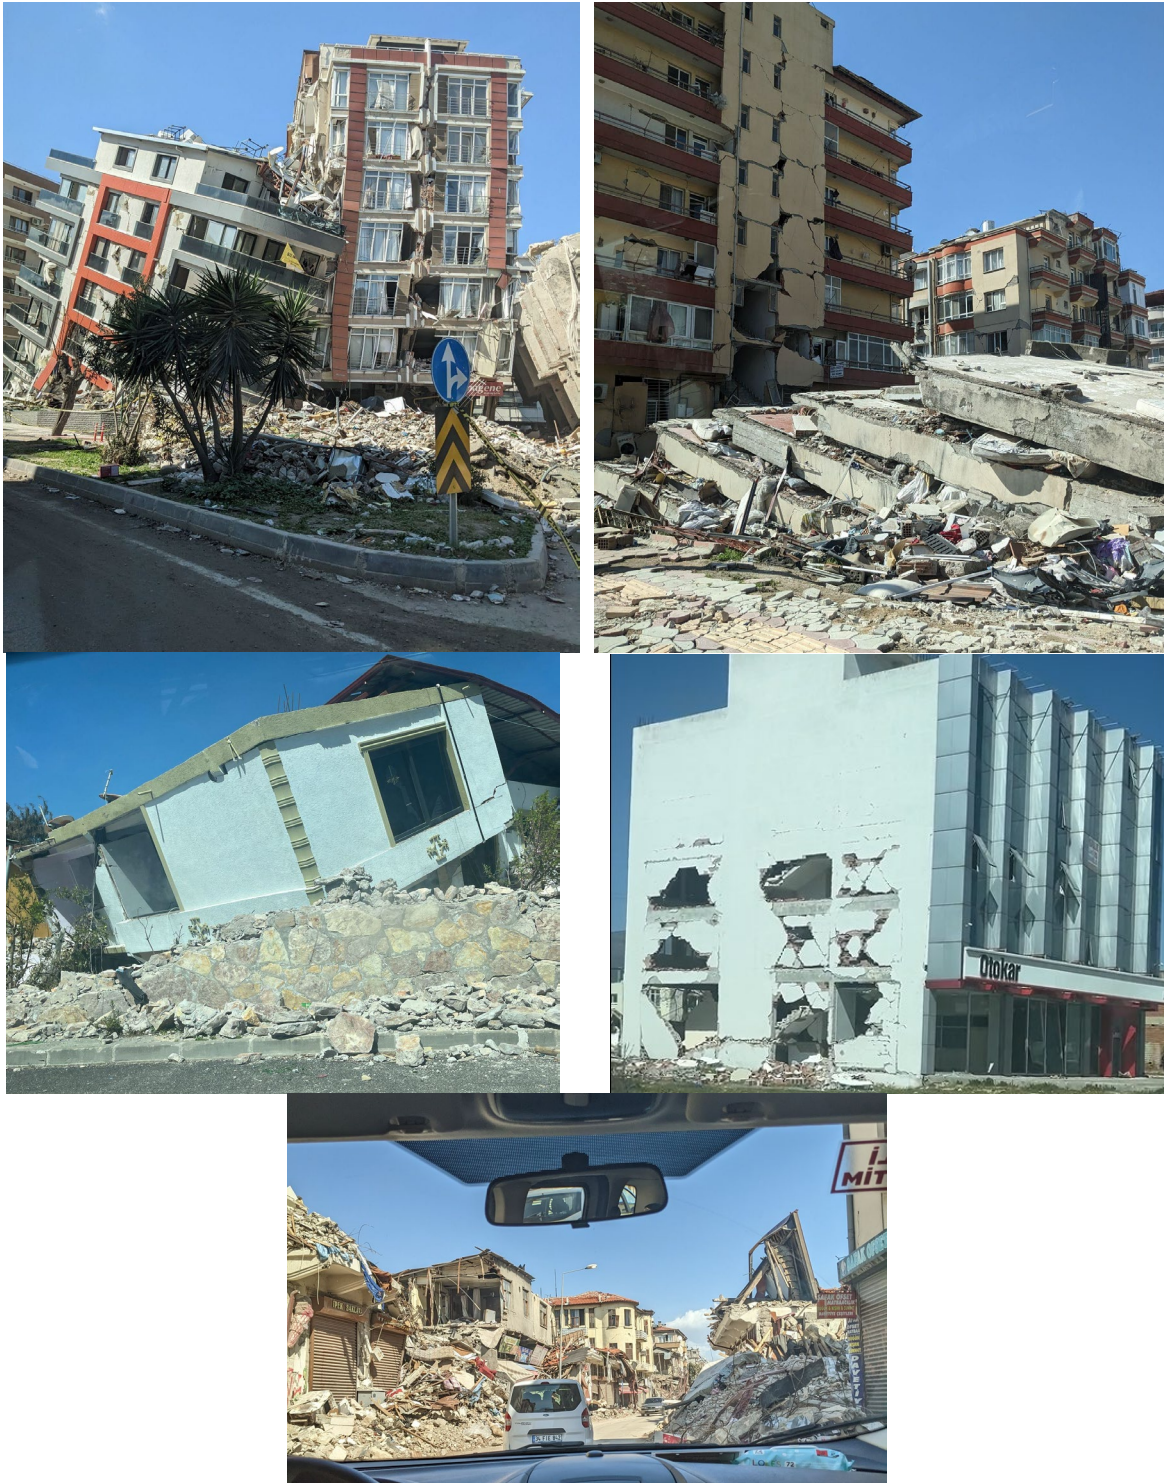
FIGURE 24 *Damage assessment of non-ductile RC Frames with or without infill walls.*

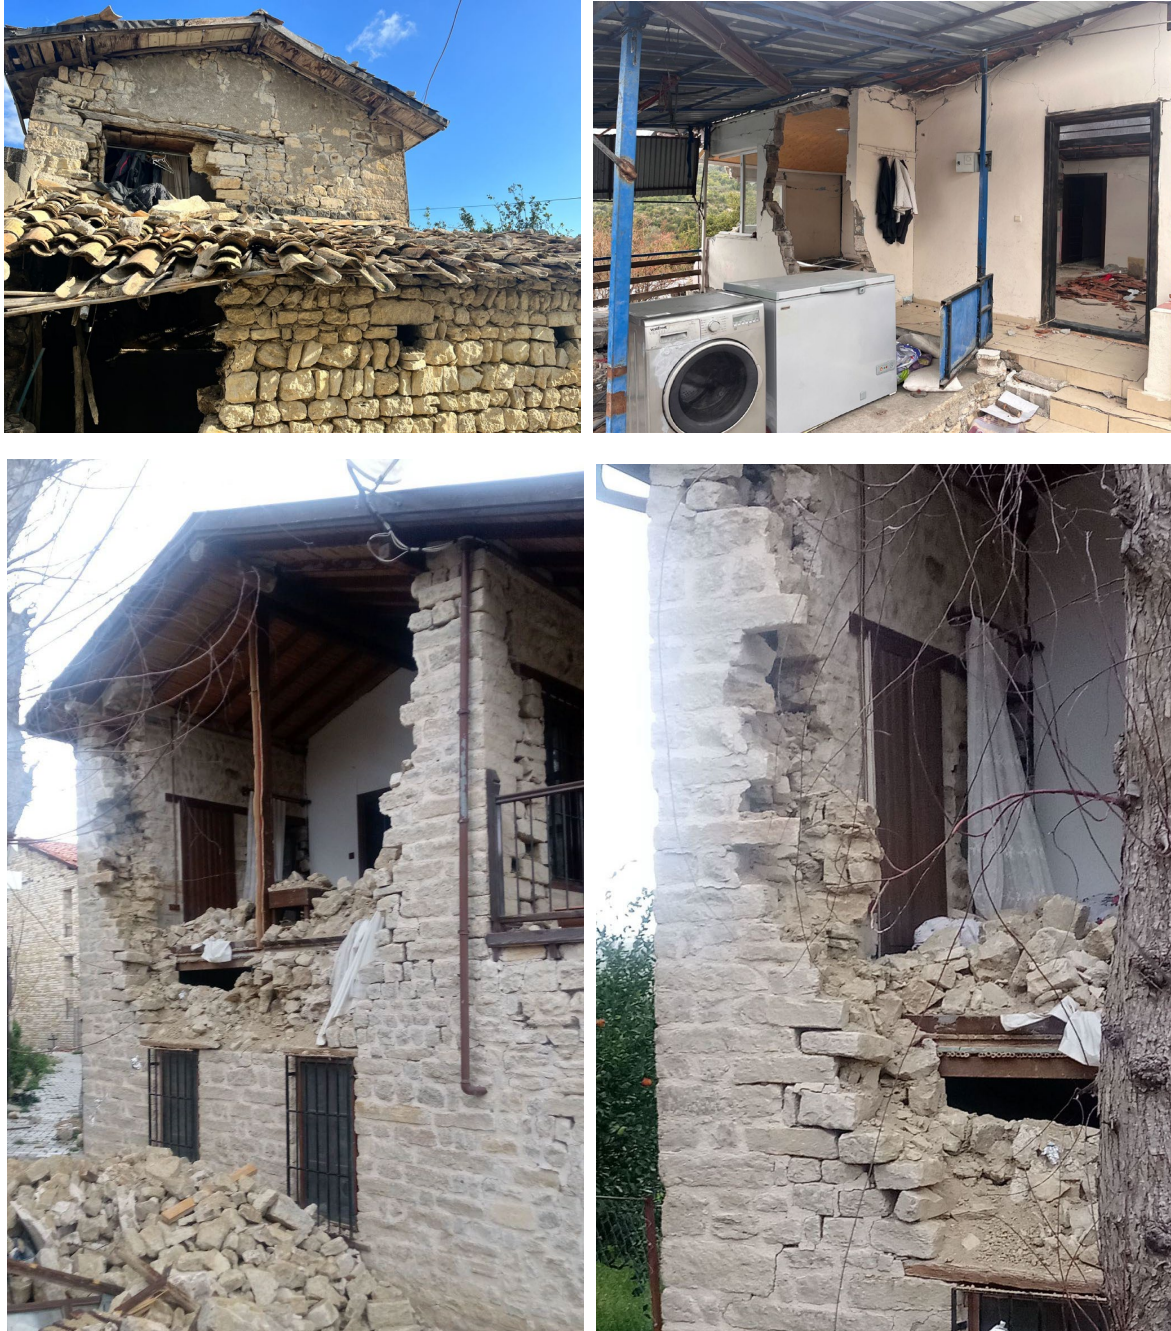
Deficiencies in design solutions, quality of materials, and construction practices are common in unreinforced masonry buildings (Figure 25). Unreinforced masonry houses are particularly susceptible to

damage or collapse due to a range of factors, such as lack of masonry confinement, insufficient connection between elements, poor workmanship in the masonry wall, tall and slender walls prone to out-of-plane failure and low-quality materials.

FIGURE 25 *Damage assessment of unreinforced masonry buildings*

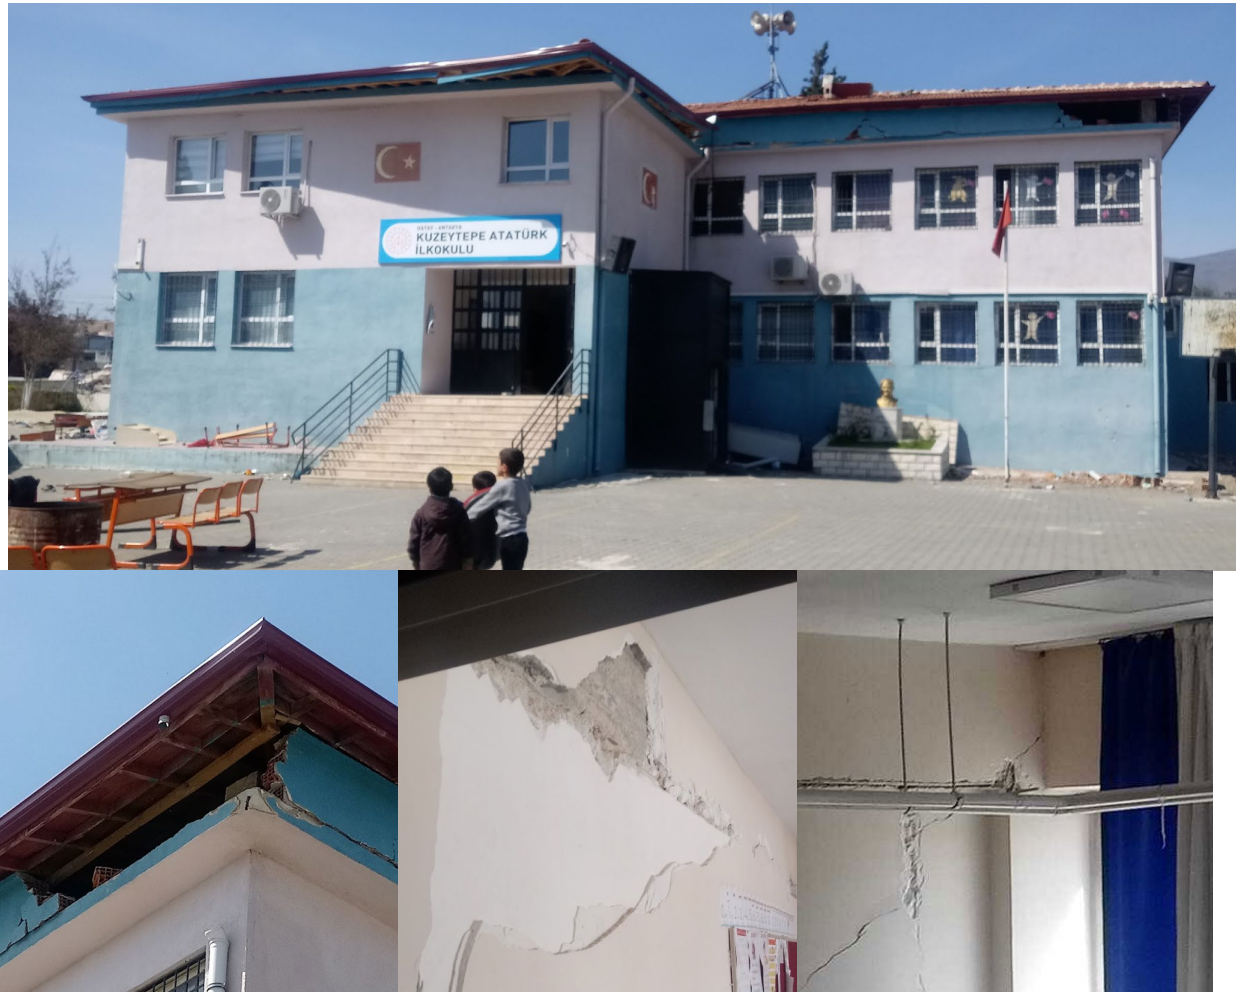
The non-structural walls and gables were the primary components that sustained damage in schools located in the most earthquake-affected areas (**Figure 26**). The schools located in Adana and Hatay

provinces rely in most cases on reinforced concrete (RC) frames with infill walls. During seismic events, these buildings experienced moderate damage, particularly in non-structural walls and gables, which often failed out-of-plane due to their weak connection to the primary structural system.

FIGURE 26 *Schools of Antakya, Hatay*
