Housing Subsector Report Mercy Corps Intervention Areas 2015 Gorkha Earthquake, Nepal

September 2015

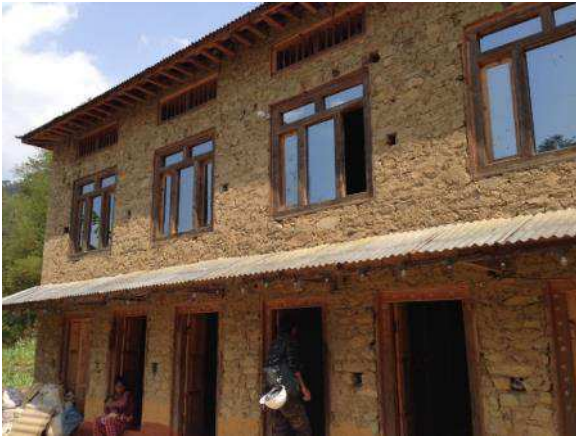
In the six villages that we visited, it was common for houses located along the main dirt roads to have multiple door openings at the ground level at both the front and back walls, refer to Figure 3.4 and Figure 3.5. One homeowner in Dhungharka explained that this was done so homeowners could operate a small business from their house. Some of the common businesses encountered in these areas were small grocery stores, restaurants, and bars. The homeowner in Dhungharka elaborated further and explained that even if a homeowner didn't intend to open his own business including multiple openings at the ground level would still be important because they could rent the space to others interested in operating a business. In cases where the space was not used for business, the extra doors were often used to provide access to storage rooms or served as separate access to living quarters for relatives.

Figure 3.4. Front of house, Chalal Ganeshthan

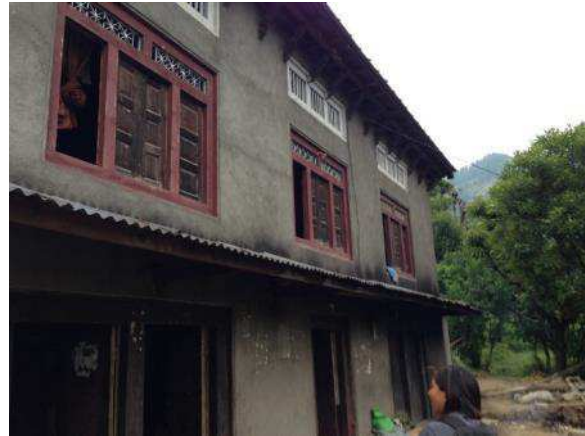
Figure 3.5. Front of house, Chyasingkharka

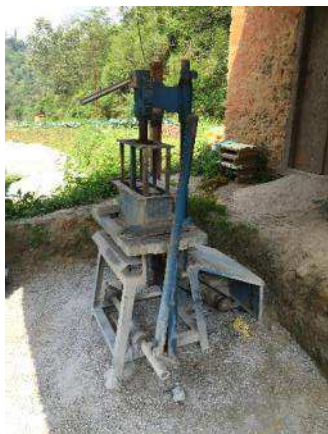
On the way to Chahal Ganeshthan there is a small concrete block making plant. There was no one at the plant at the time of our visit so it was not possible to observe how the blocks are manufactured, or if the blocks are tested for strength, or to identify the block maker's sources for the raw materials. However, our experience with concrete block manufacturing has shown that in cases where blocks produced have low strengths, that with relatively inexpensive modifications to production, much stronger blocks can be produced instead.

Figure 3.15. Concrete block making machine

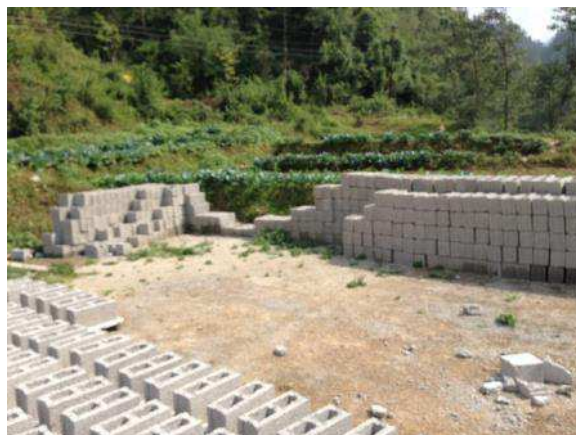
Figure 3.16. Drying and stacking of concrete blocks at the plant near Chalal Ganeshthan

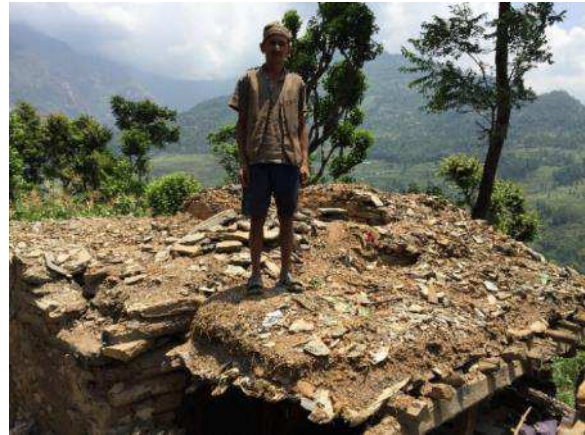
The damage in Ramche was severe. Approximately 90% of the houses observed had completely collapsed and the remaining structures were partially collapsed or damaged to the extent that they were not safe for future habitation. Many people have built temporary

Figure 3.25. Shiva Prasad on the first floor level of his house.

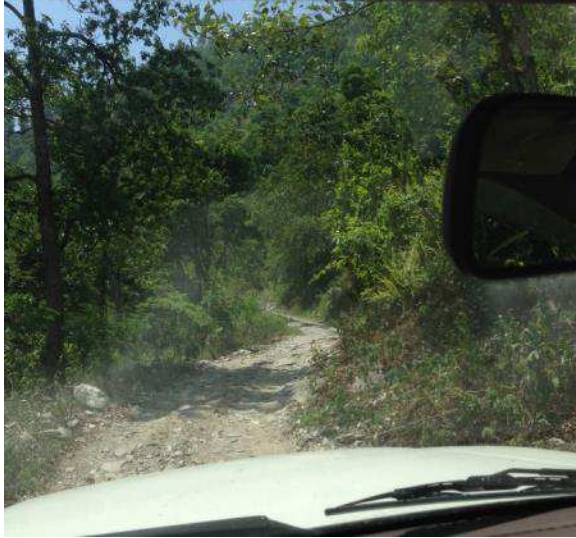
rain event the roads become muddy, which combined with the steep slope and the ruts in the road make them virtually impossible to drive on. The hillsides are also prone to landslides, which according to the villagers frequently occur during rains and block the roads. There were also reports of landslides that were induced by the April earthquake that cut off access to roads. [9]

Figure 3.27. Road to Ramche

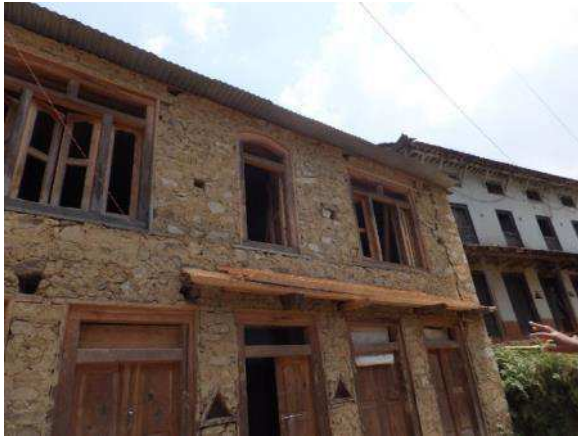
In Dhungharka and Chalal Ganeshtan it was common practice to install triangular holes in the walls at the front of the house. These holes were for religious shrines. While the survey team did not see any evidence of earthquake damage to the walls resulting from the presence of these holes, their presence within the shear walls of the houses would likely have an effect on the capacity of the walls to resist seismic loads. These holes were not seen in the other villages.

Figure 3.29. Front of house, Dhungharkha

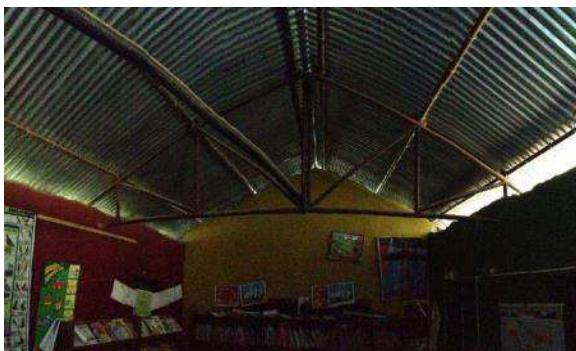
Some of the schools in the villages surveyed had steel framed roofs consisting of either light gage steel channels or trusses framed with small steel tubes. Typically the walls of these schools were built with stone masonry, though in most cases these walls did not support the roof structure. Instead the roofs were supported by steel posts embedded inside the masonry. Most of the school buildings that had this type of construction had damage to the stone walls but in every case the roof framing remained standing. Some of the residents of Ramche observed the lack of collapses of steel framed structures and advocated for using them for houses.

Figure 4.4. School in Dhungkharka with steel framing

Constructing houses with steel framing could be a potential option since they have a good record of performance and are lightweight compared to masonry or concrete structures. The primary challenge to adopting this system would be the availability and cost of the steel material and the ability of the local builders to construct it properly. Of the school buildings that the survey team found in the villages with steel framing only the school in Dhungkharka was constructed by a local builder (though the school in Ramche was being repaired by local builders). In the other villages the school was constructed by builders from outside the village and funded either by the government or by an outside non-government organization.

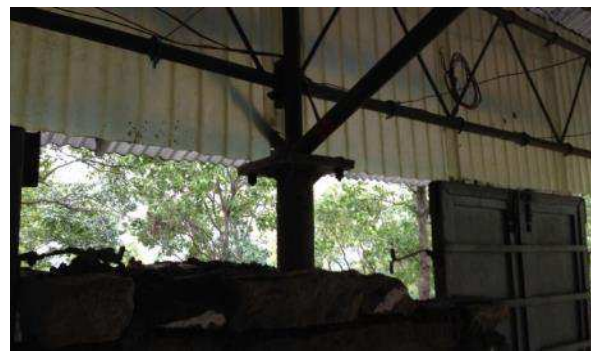
Figure 4.5. Steel framed school in Ramche
