BUILD CHANGE NEEDS ASSESSMENT AND POST-DISASTER RECONNAISSANCE REPORT

2023 TÜRKİYE EARTHQUAKE

MARCH 2023

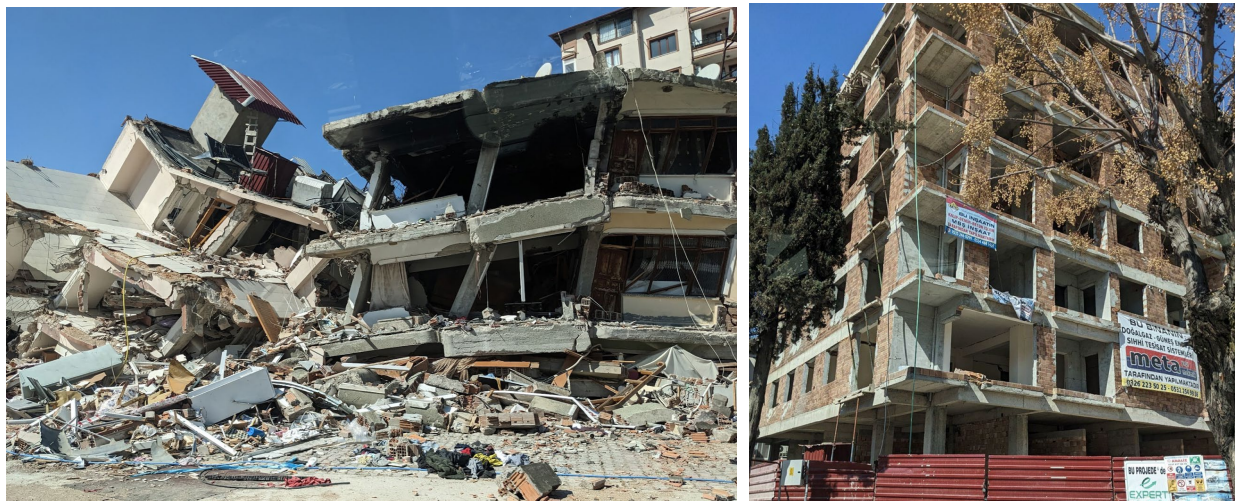
FIGURE 11 RC shear walls and beam-column frames in urban areas in Antakya, Hatay

The most common structural typology for both commercial and residential buildings in the urban and rural areas visited is multi-story RC frames with infill walls (Figure 11 and Figure 12). The structural system consisted of RC columns and beams creating moment resisting frames in both directions, RC floors and roofs and unreinforced masonry infill. Buildings located near principal roads typically had commercial spaces on the ground floor, which often resulted in soft/weak story irregularity. Occupied cantilevers at both ends of the beams were also frequently observed in both urban and rural areas.

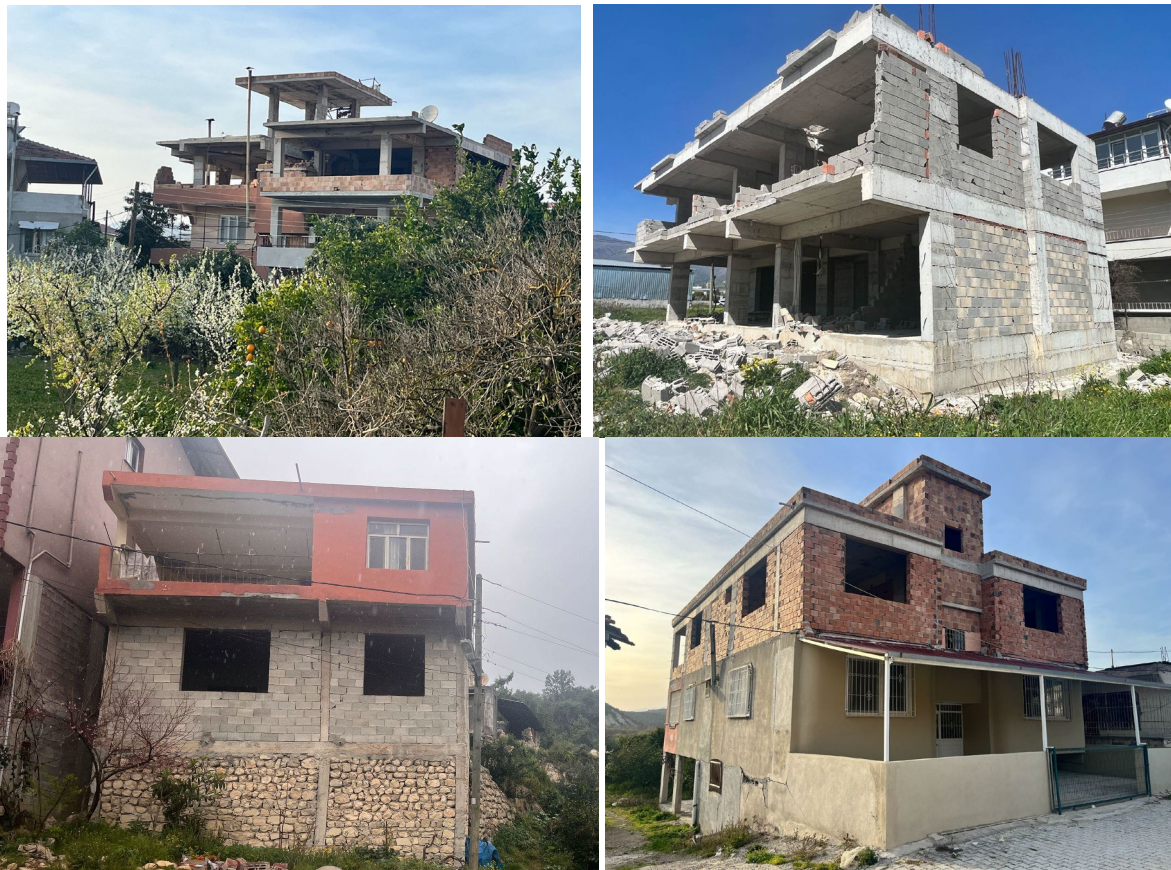
FIGURE 12 RC frames in rural areas in Defne, Hatay

In both rural and urban areas, pumice concrete blocks and hollow clay bricks were commonly used for infill walls. Regulated structures always had RC foundations, while non-regulated ones were constructed using both RC foundation and stone masonry footing. In rural areas, stone masonry was frequently used for infill walls, usually at the foundation and ground level.

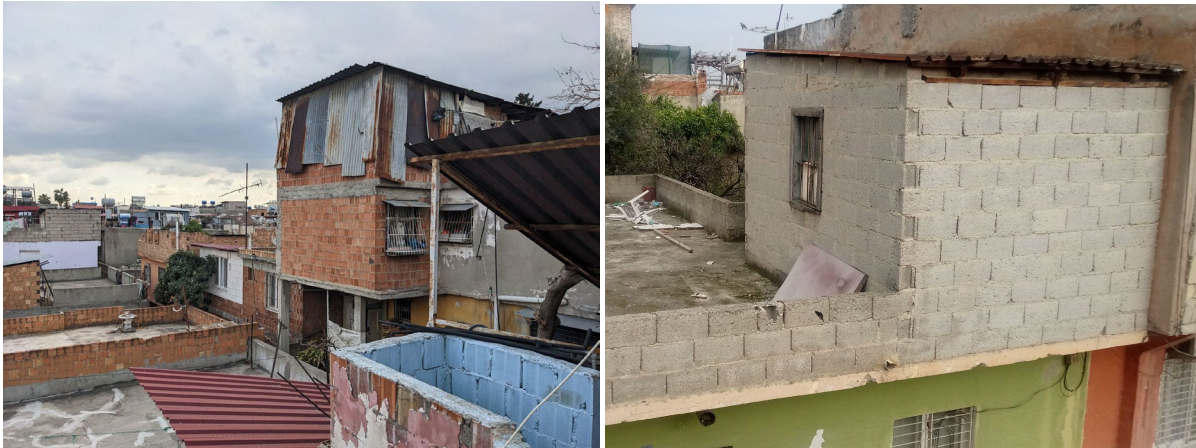
FIGURE 13 *Unreinforced masonry in urban areas (Adana)*

In the urban areas visited, particularly in non-regulated neighborhoods, low-rise buildings made of unreinforced masonry can be found (Figure 13) but are not the most common structural typology. These buildings are constructed using hollow clay bricks and pumice concrete blocks, with cement mortar and wall thickness varying between 12 cm and 15 cm, depending on the material used. The floor system of these buildings consists of solid reinforced concrete slabs that are supported by the walls. The roof system is lightweight and can be made of metal or wood purlins or a solid reinforced concrete roof. A typical house distribution of the visited areas, comprising two or three floors with open spaces, is shown in Figure 14.

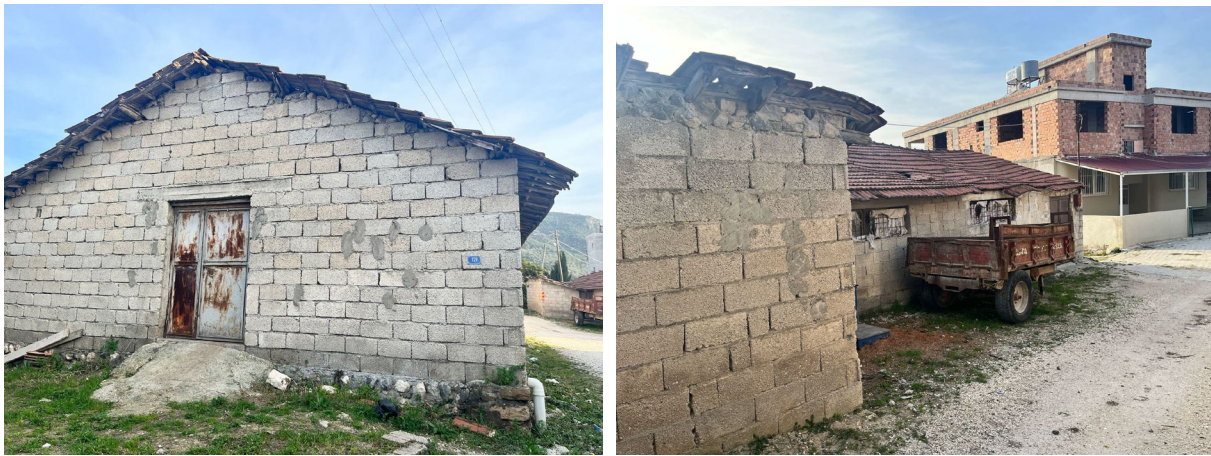
FIGURE 15 *Unreinforced block masonry buildings in Balıklıdere village, Hatay*

During the visit to rural areas, it was observed that unreinforced masonry buildings are predominantly used as storage facilities and animal farms (Figure 15). The common roofing system in these buildings consists of wood purlins and clay roof tiles. In the Samandağ district of Hatay province, stone masonry foundations and walls, particularly for the ground floor, using mud or cement as mortar, were frequently found (Figure 16). The buildings in this region typically have wood-framed floors with a thin layer of concrete or RC slabs resting on the walls and wood-framed roofs with clay tiles (Figure 17). In some cases, pumice concrete blocks and/or brick walls were constructed above the stone walls.

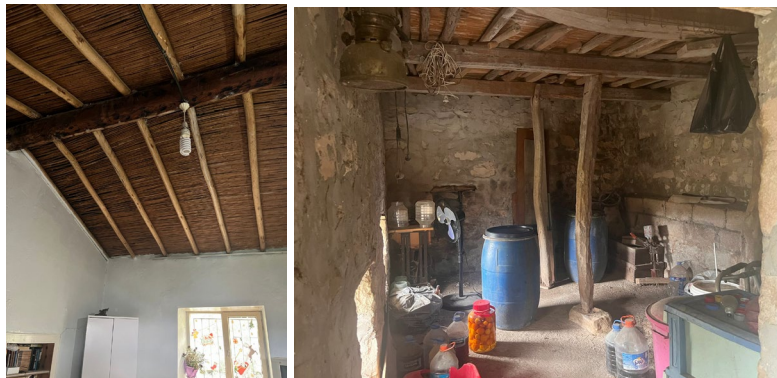
FIGURE 17 Roof and floors of an unreinforced stone masonry house in Vakıflı Village, Hatay. Pictures of a one-story house. The figure on the left shows the roof at the first floor and the figure on the right shows the basement.

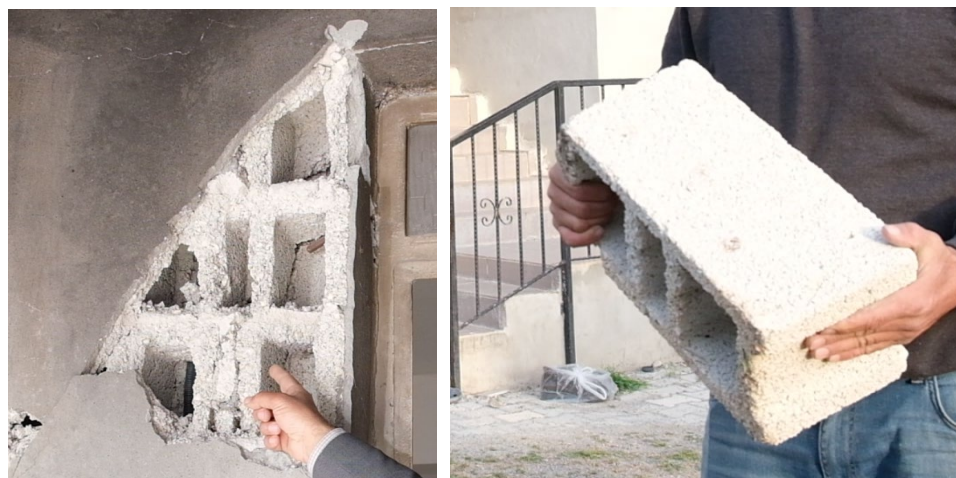
The locals in the area commonly use pumice concrete blocks for infill walls in ground floors of RC frame structures and unreinforced masonry. This material is not preferred for use in upper floors due to its weight and, despite the availability of different sizes, the typical 39x20x18 cm vertically perforated block is often used. After conducting site visits, it was identified that certain areas displayed substandard masonry. Additionally, there were cases of incorrectly oriented (horizontal instead of vertical) pumice concrete blocks, as shown in the first picture of **Figure 18**. The blocks are usually laid using cement mortar. All the materials are generally locally available, according to builders in Adana, Hatay and Istanbul.

FIGURE 18 Pumice concrete blocks used as structural material in unreinforced masonry buildings and as non structural material in the infilled walls of RC Frames.

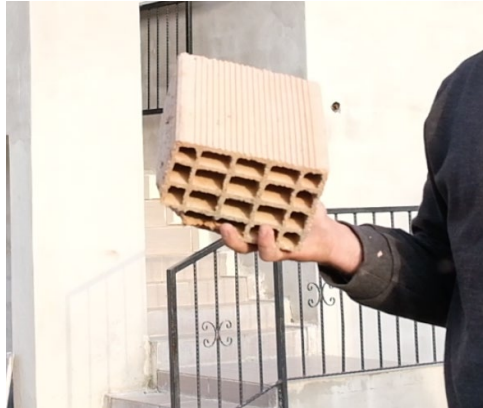
Hollow clay bricks (**Figure 19**) are frequently used in both regulated and non-regulated buildings as infill walls. In the rural regions of Hatay, hollow clay bricks are preferred to be used in upper floors due to its

low weight. The standard size is usually 14x19x19 cm¹² and cement mortar is commonly used to lay the bricks.

FIGURE 19 *Hollow clay bricks mainly used as non structural material in infilled walls in RC Frames.*

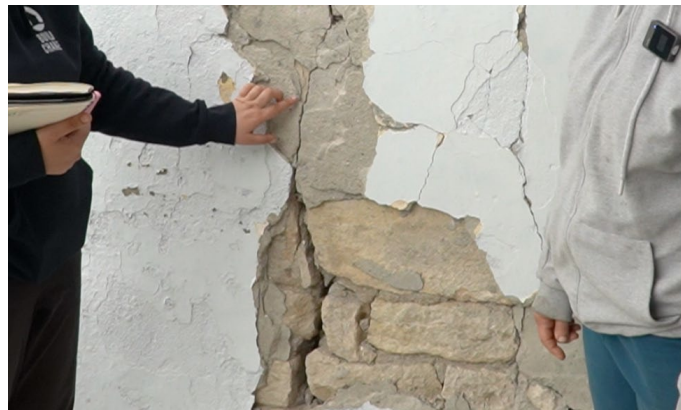
FIGURE 20 *Stone masonry found in rural areas*

Stones are a prevalent building material in the unreinforced masonry buildings found in rural areas (Figure 20), particularly limestones. The walls of these structures are typically constructed using a combination of mud mortar and cement mortar. Stone sizes and shapes vary from house to house, with some stones being rectangular and closer in size to bricks, while others are larger in size.
